Long-Term Integrity Testing of Water-Swelling and Oil-Swelling Packers

Sayyad Zahid Qamar, Maaz Akhtar and Tasneem Pervez

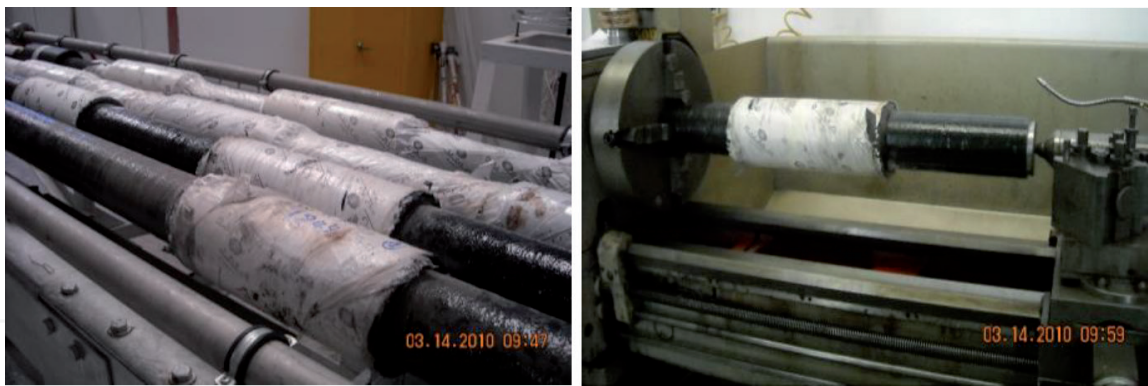
Figure 4.
Full-length elastomer tubulars (left); sizing and beveling of elastomer packers (right).

Swelling elastomer pipes and outer steel casings were provided by a regional petroleum development company. Elastomer sections were mounted on steel tubulars, different ones for low-salinity and high-salinity water, and crude oil; **Figure 4**. Sections of one-meter length were cut out from these tubulars, followed by sizing and trimming to get the swell packers and outer casings. Beveling was required for welding operations to be carried out at one end of the packers, and both ends on the casings; **Figure 4**.

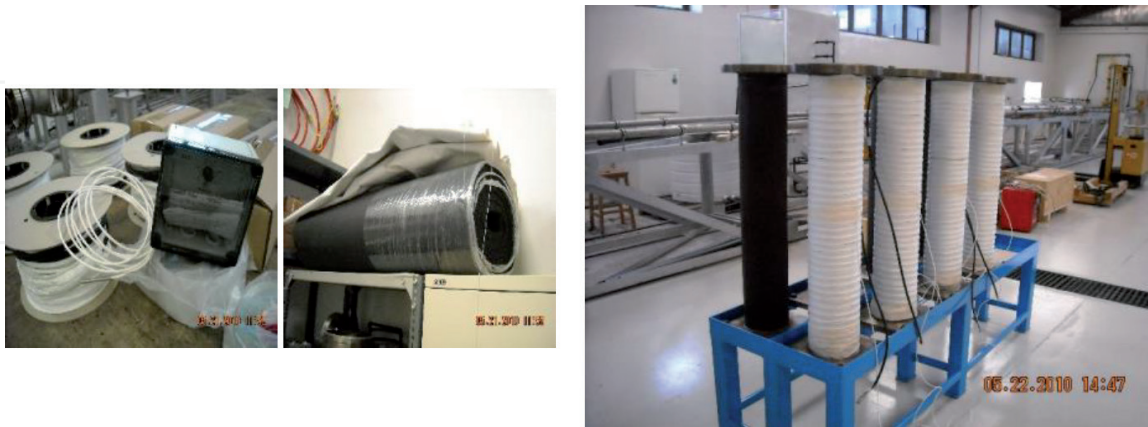
Figure 8.
Thermal system components (left); winding of thermal blankets on casings (right).

Thermal blanket system was imported from a company that specialized in custom-designed heating units. Assembly was done in-house and the thermal units were installed on four high-temperature packers; **Figure 8**. Joining of packers to casings was done flange-to-flange, with custom-built pressure seals in between. Pressure gauges were fitted on top of the upper flanges for all units, and temperature gauges for the four 50°C units; **Figure 9**.

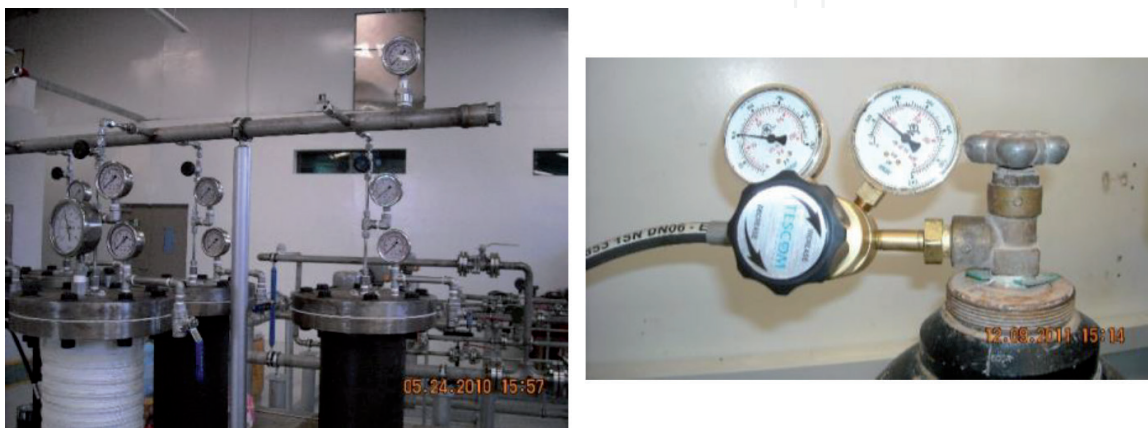
Figure 10.
High-pressure manifold with connections to test units (left); pressure regulator to control high pressure flow into the test units (right).

A manifold system was fabricated and installed, using special valves, to apply and maintain high pressure when needed; **Figure 10**. Main part of this manifold system was a SS pipe that was to be later connected to a high-pressure nitrogen gas cylinder. It had nine specially-fabricated outlets, hooked up to the test units, containing SS high-pressure (100-bar) needle valves and pressure gauges. High-pressure multistage gas regulator and related fittings were affixed to the nitrogen cylinder, to control the flow pressure in the manifold and the packer units; **Figure 10**.

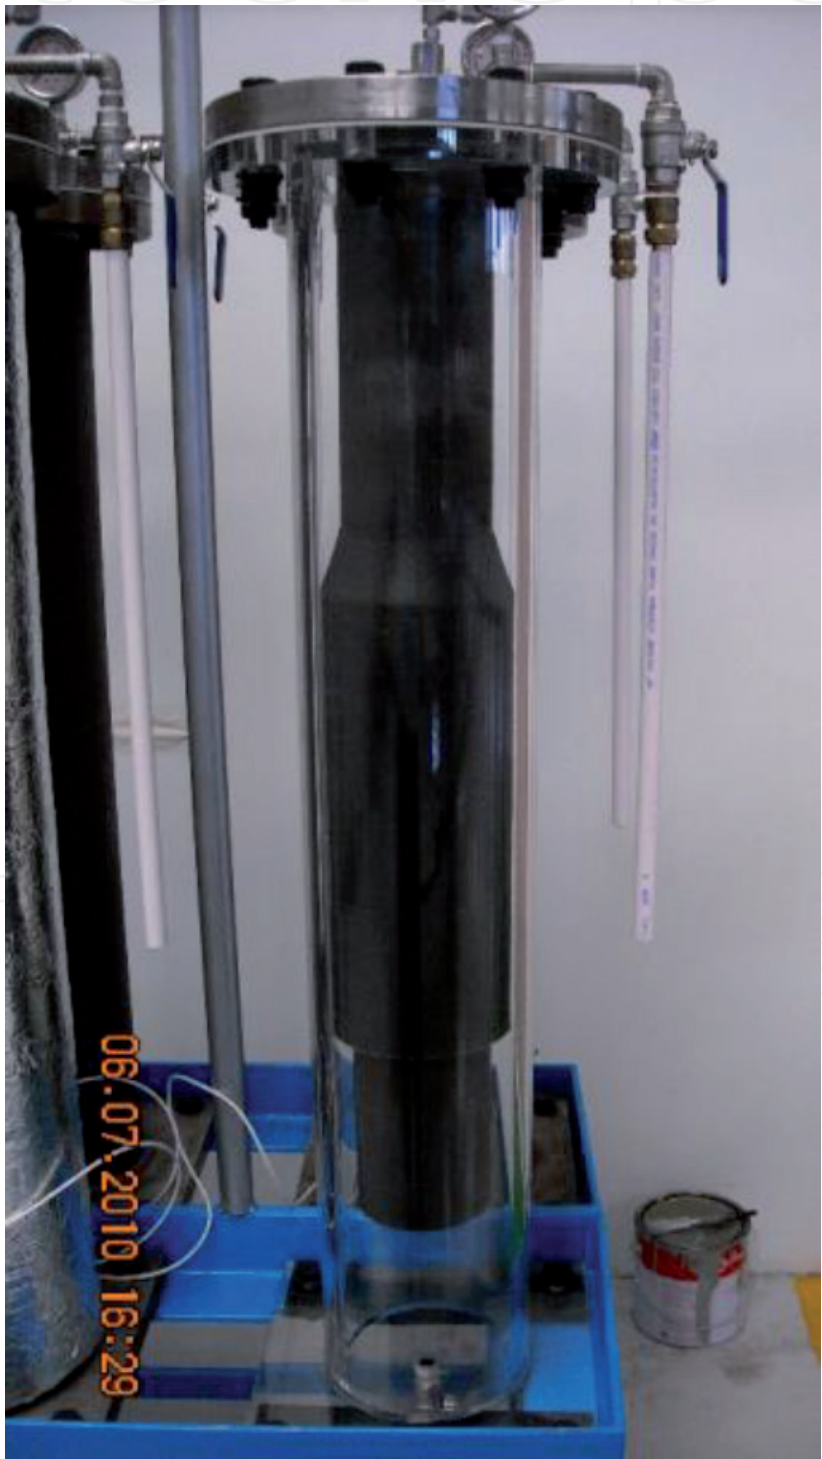
Figure 11.
Perspex demonstration unit showing internal construction of other test units.

Detail and assembly drawings for the demonstration unit were sent to a specialist facility for fabrication, the outer casing and the blind flange to be made of transparent Perspex. This see-through unit had all the components and was assembled to exactly match the other functional test units; **Figure 11**.

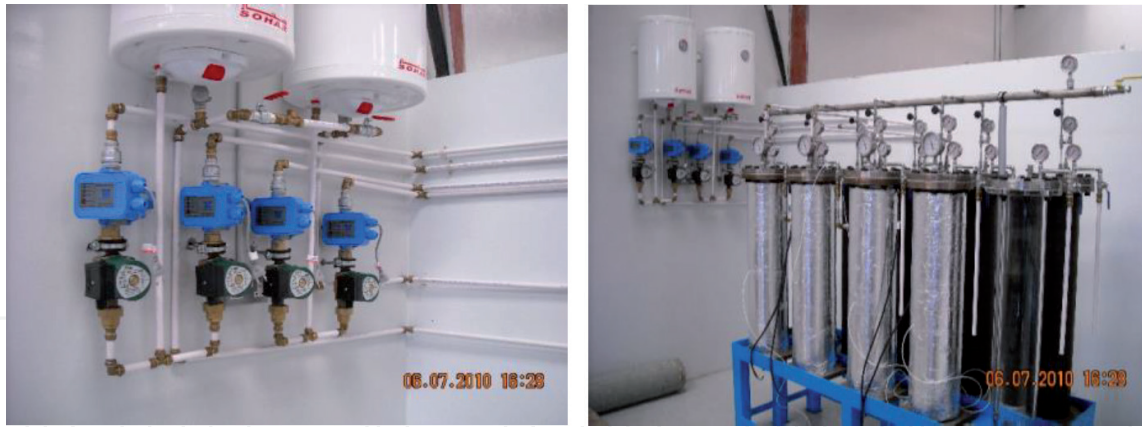
Figure 12.
Ambient and hot water circulation system (left); complete assembly of the longevity test setup.

A circulation system was fabricated and installed on the four water-swelling packers, to maintain the salt concentration. It consisted of two water heaters (50-ltrs), three circulating pumps, and four each of pressure controllers, non-return valves, filling ports with valves, air vents, and running-time meters. All of these were connected together through copper lines; **Figure 12**.

All the components and sub-assemblies were finally assembled together; **Figure 12**. Cutting, trimming, beveling, drilling, threading, bending, and welding were some of the major fabrication operations. SS and PVC pipes, flexible hoses, valves, pressure and temperature gages, circulation and heating system, etc. were fitted at required locations. Forty sets of M16 x 100 and 80 sets of M16 x 80 hexagonal bolts (together with nuts, washers, and spring washers) were employed for different types of connections: packer blind flanges to flanges on outer casings; bottom end plates on casings to base frame; etc.

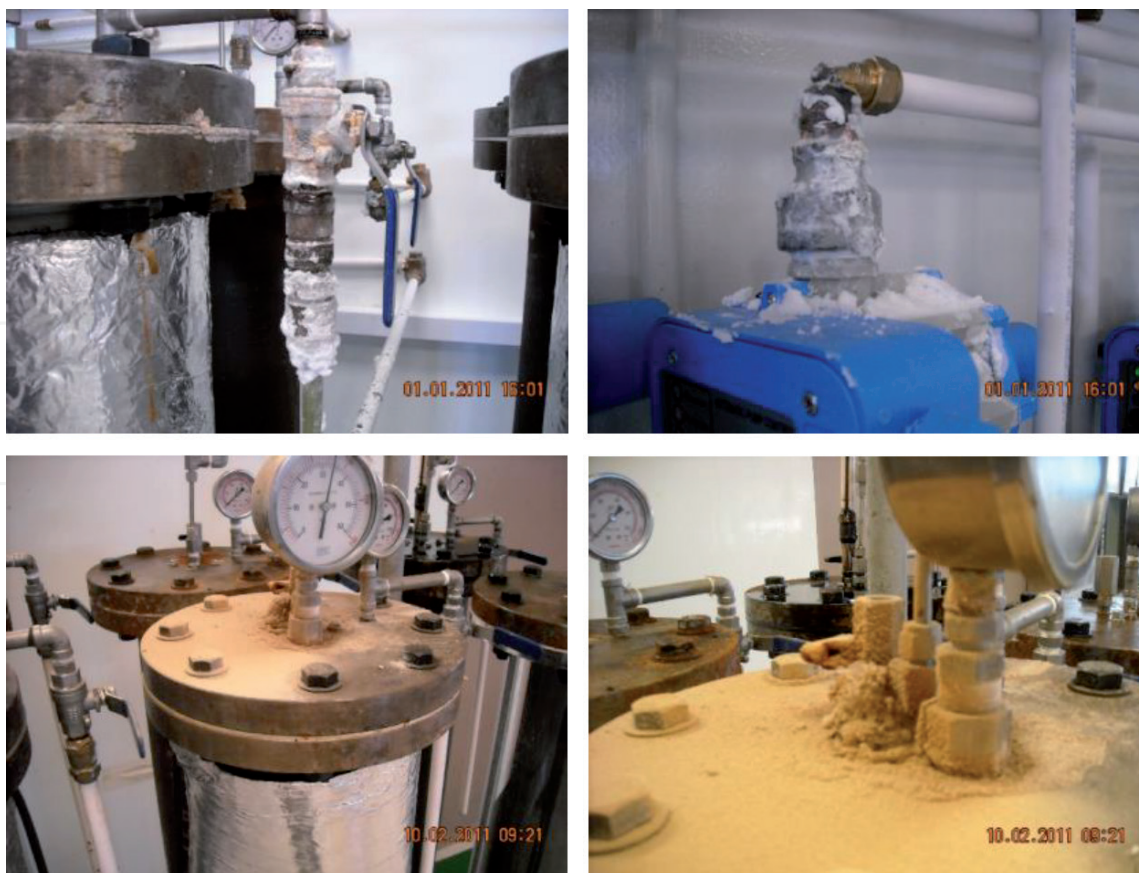
Figure 13.

Salt deposition on pipes, fittings, and pump units due to water leakage (top); corrosion of pipes and fasteners due to water leakage and salt deposition (bottom).

As mentioned above, a circulation system was needed to maintain salt-concentration in the 4 high-salinity (12%) units. Small leakages repeatedly occurred in various portions of the circulation system, causing salt deposits on pipes and fittings. Water leakage and salt deposition also caused rusting of the tubes, flanges, and other fittings; **Figure 13**. The system had to be monitored on a daily basis, and clean-up, re-tightening and re-sealing operations had to be frequently carried out. Salt leakage also meant that water salinity would change. So salinity checks and refilling of tubes was also needed occasionally.

Intermittent shutting down of circulation pumps was another problem, caused by the formation of air gaps in the system due to small leakages. Urgent refilling and bleeding were needed to solve this problem, to avoid any notable downtime in the
